Manhole Inspection Summary

Manhole # S45E2_020MH

Insp Date: **1/4/08 8:54 AM**

Location Address: **4118 Fairhaven Ave**

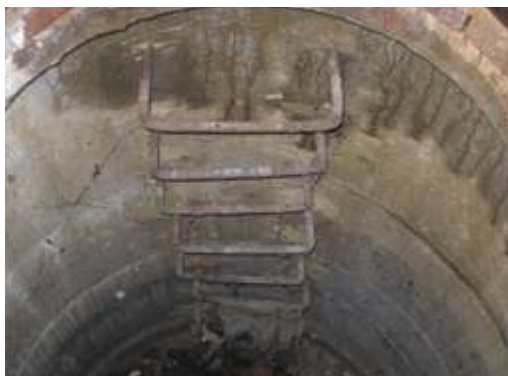
Steps Count: **8** Missing: **0** ☐ Corroded

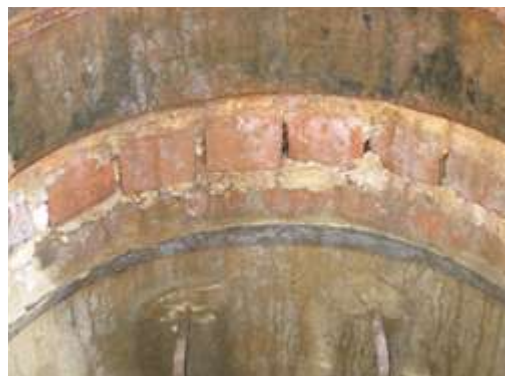
Defect 1

Condition: ☐ Sound ☐ Cracked ☐ Root Intrusion ☒ **Loose Brick** ☐ Deteriorated

Infiltration: ☐ None ☒ **Joint** ☐ Cracks ☒ **Mortar** ☐ Roots ☐ Wall

Infiltration

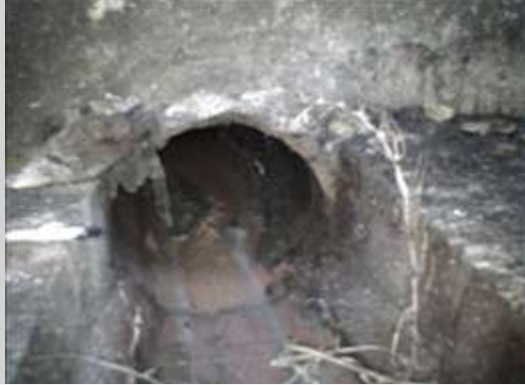
12 O'Clock Outflow

8 in. Circular Gravity Sewer
Pipe Out @ 12 O'Clock

Pipe Height: **8.4** (in.) Rod and Bar (Angled)
Pipe Material: **Clay** ☐ Pipe Lined
Invert Depth: **11.27** (ft.) Flow Characteristics: **Fast**
Deposits: ☒ None ☐ Mud ☐ Sludge ☐ Debris ☐ Grease
Silt Depth: (in.) Deposits Extent:
Infiltration: **None** Pipe Seal Cond: **Sound**

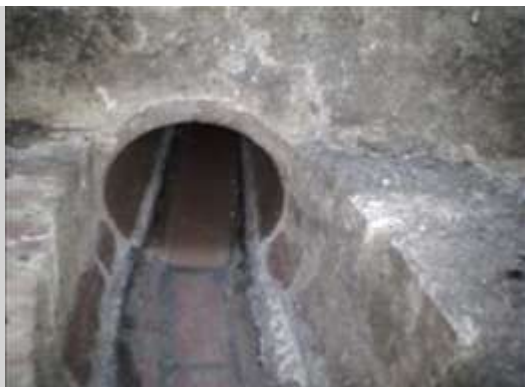
9 O'Clock Inflow

8 in. Circular Gravity Sewer
Pipe In @ 9 O'Clock

Pipe Height: **9.6** (in.) Rod and Bar (Angled)
Pipe Material: **Clay** ☐ Pipe Lined
Invert Depth: **11.28** (ft.) Flow Characteristics: **Fast**
Deposits: ☒ None ☐ Mud ☐ Sludge ☐ Debris ☐ Grease
Silt Depth: (in.) Deposits Extent:
Infiltration: **None** Pipe Seal Cond: **Sound**
